# *Final Report*

## **Deflecting the Wave: Using Coastal Vegetation to Mitigate Tsunami and Storm Surge**

Tropical Landscape and Human Interaction Lab  
Department of Tropical Plant and Soil Sciences  
College of Tropical Agriculture and Human Resources  
University of Hawai‘i at Mānoa

**June 2015**

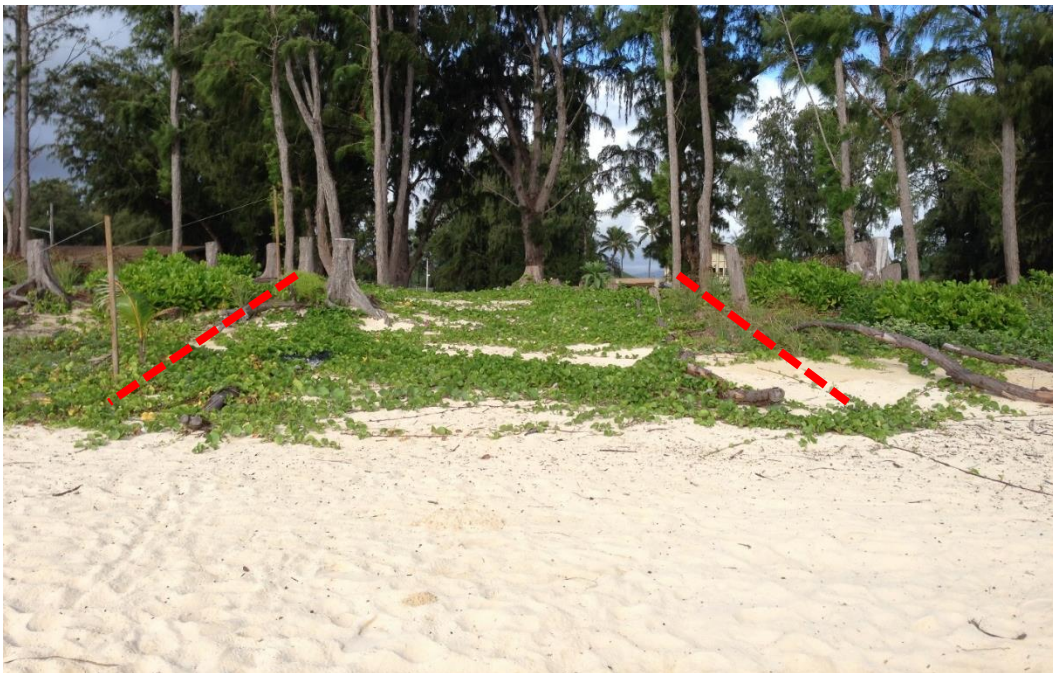
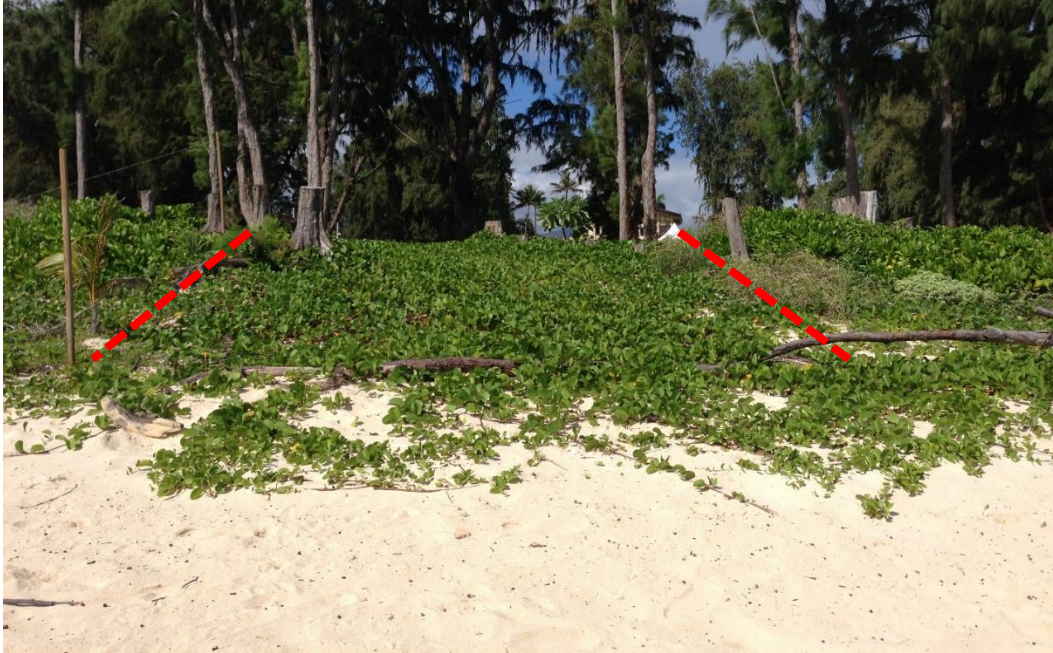
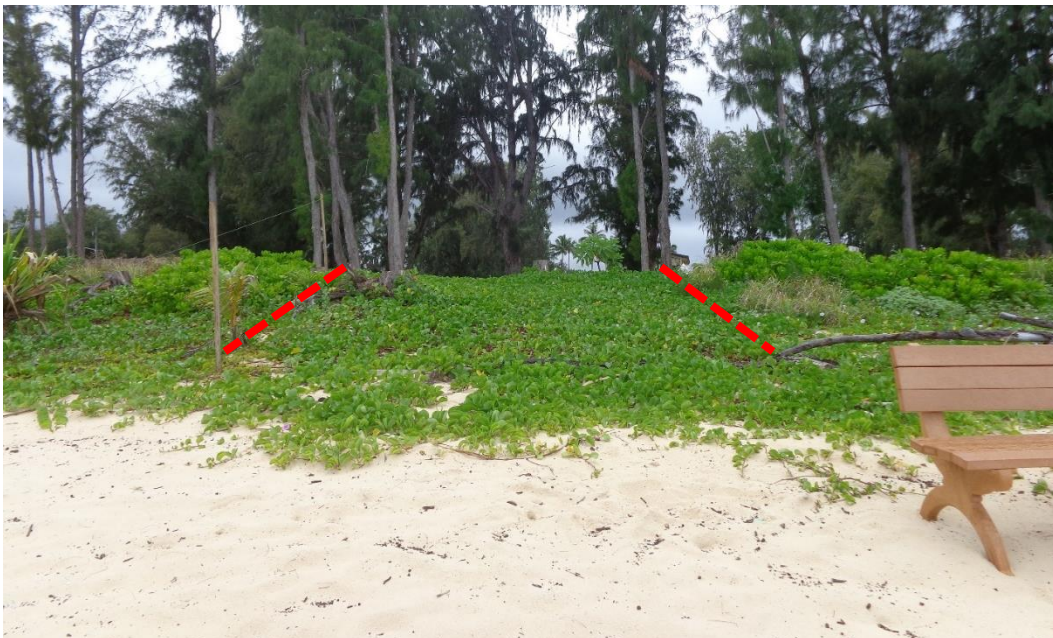
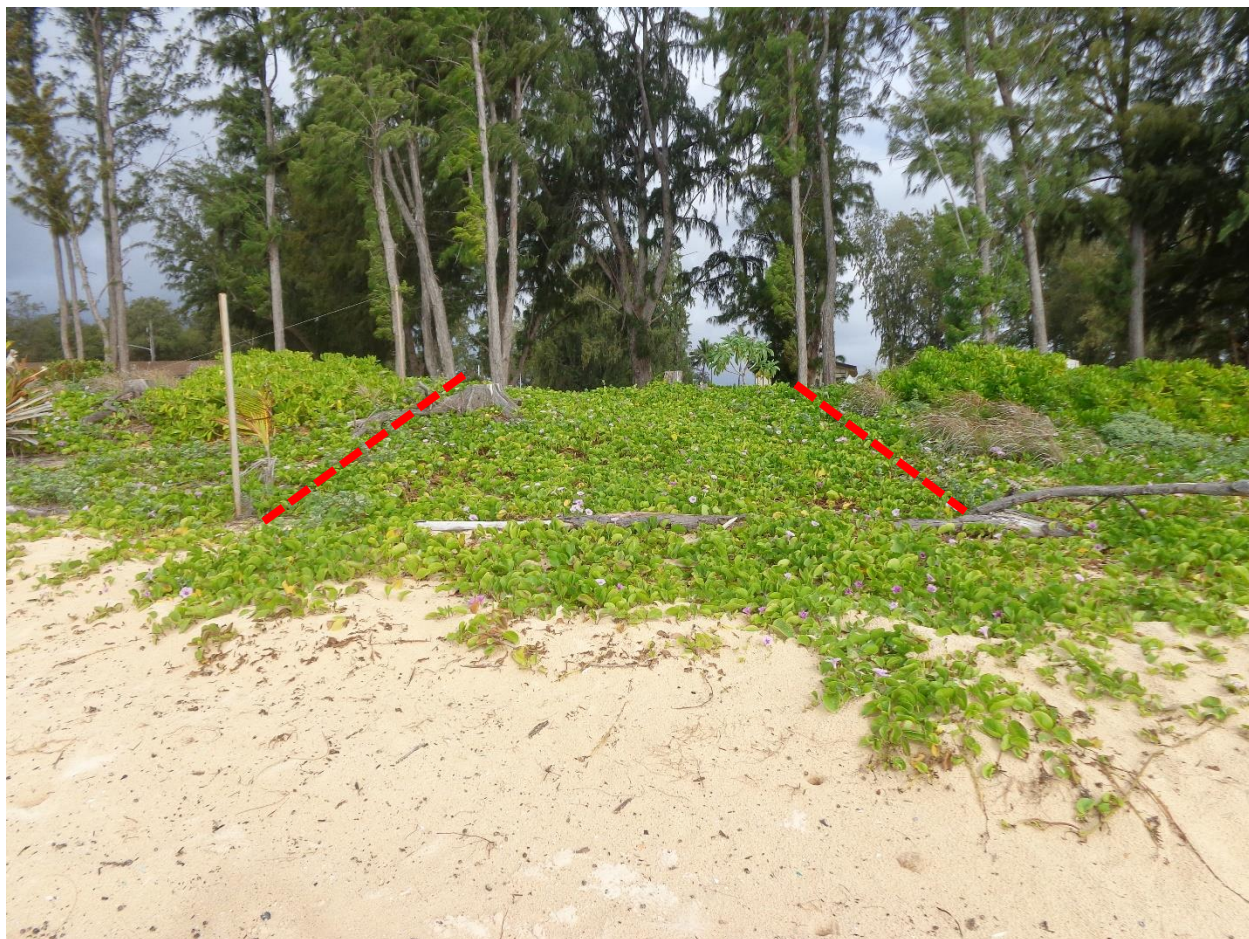
Figure 151. Detail of area covered by *Ipomoea pes-caprae* subsp. *brasiliensis*, 9 months after planting (01/27/2015). The area between the two dashed lines was not planted nor received irrigation.

Figure 152. Detail of area covered by *Ipomoea pes-caprae* subsp. *brasiliensis*, 9 months after planting (01/27/2015). The area between the two dashed lines was not planted nor received irrigation.

Figure 153. Detail of area covered by *Ipomoea pes-caprae* subsp. *brasiliensis*, 9 months after planting (02/27/2015). The area between the two dashed lines was not planted nor received irrigation.

Figure 154. Detail of area covered by *Ipomoea pes-caprae* subsp. *brasiliensis*, 12.5 months after planting (05/01/2015). The area between the two dashed lines was not planted nor received irrigation.

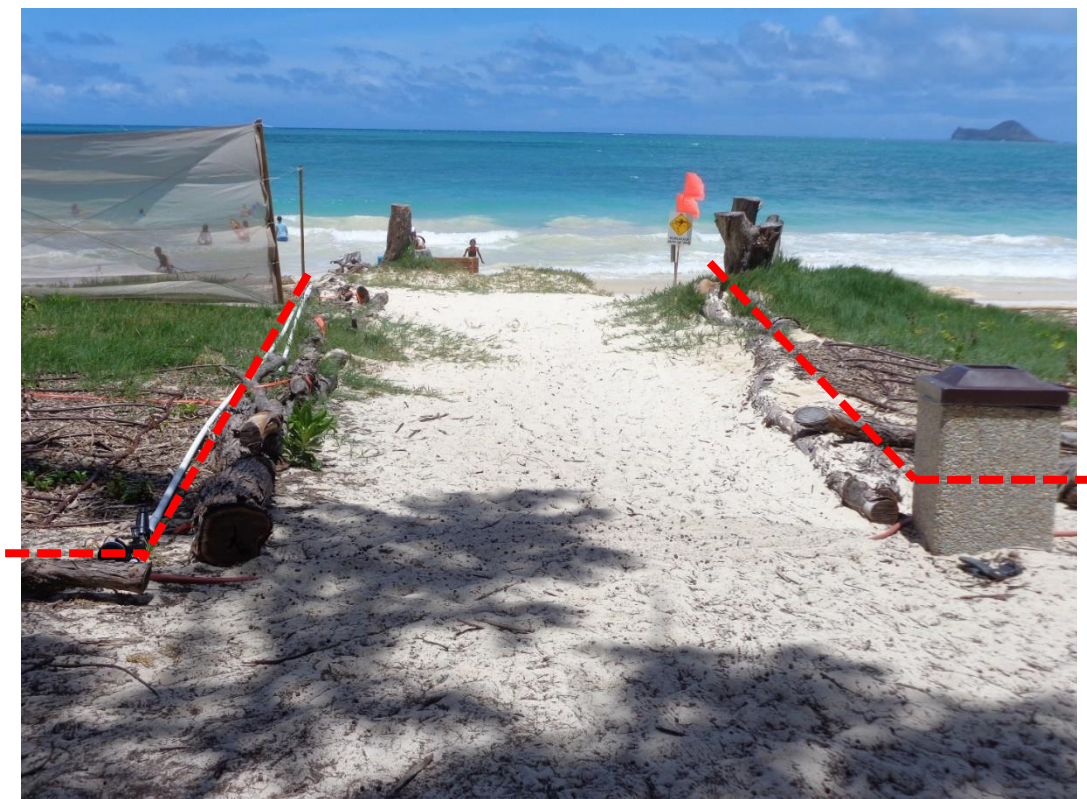
Figure 155. Plot 1 three months after planting (07/09/2014), with a wide space between plots, around 10ft.

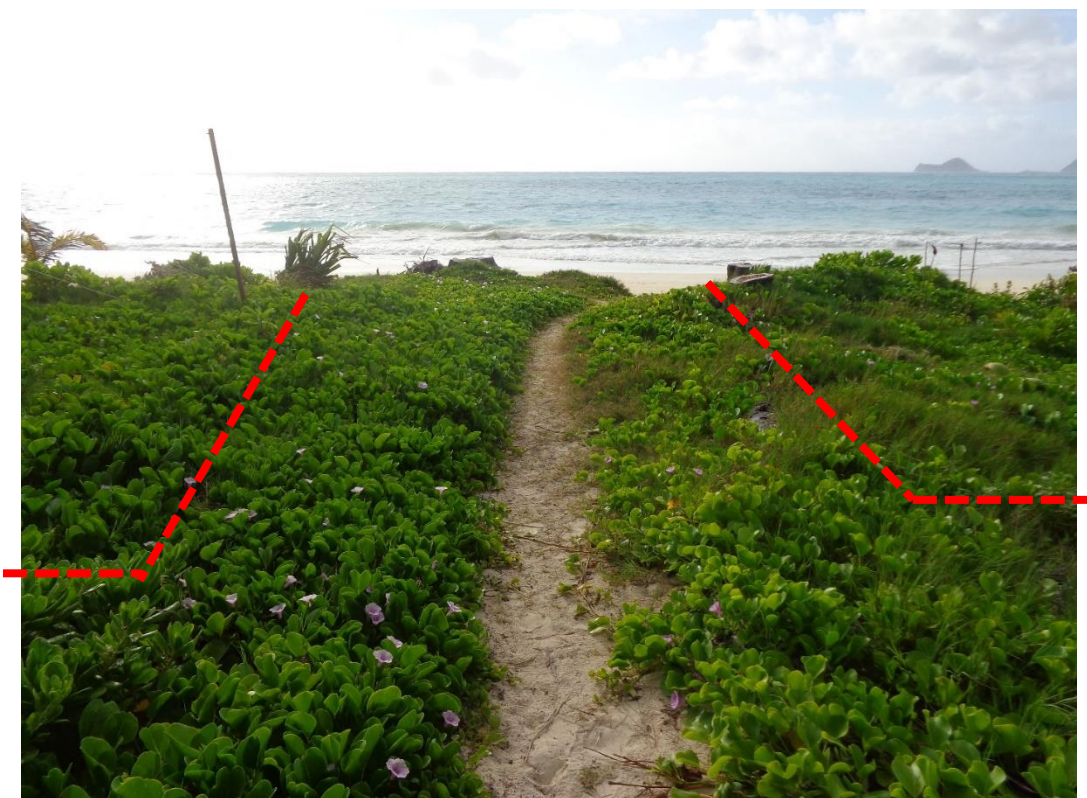
Figure 156. Plot 1, thirteen months after planting (5/01/2014), *I. pes-caprae* almost closed the walkway between the two plots.

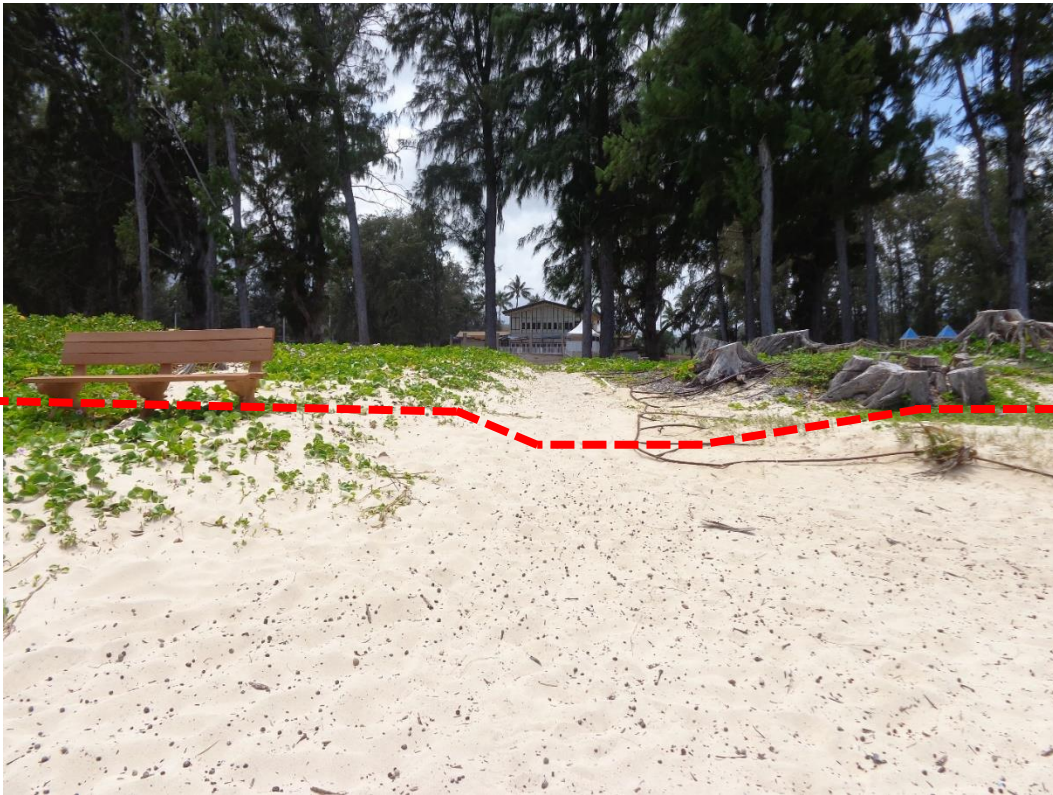
Figure 157. Picture taken 13 months after planting (05/18/2015), showing how the ground cover *Ipomoea pes-caprae* subsp. *brasiliensis* is associated to the trapping of sand, adjacent to a plot planted in November 2014. The dashed line represents a profile of the sand dune level 13 months after planting.

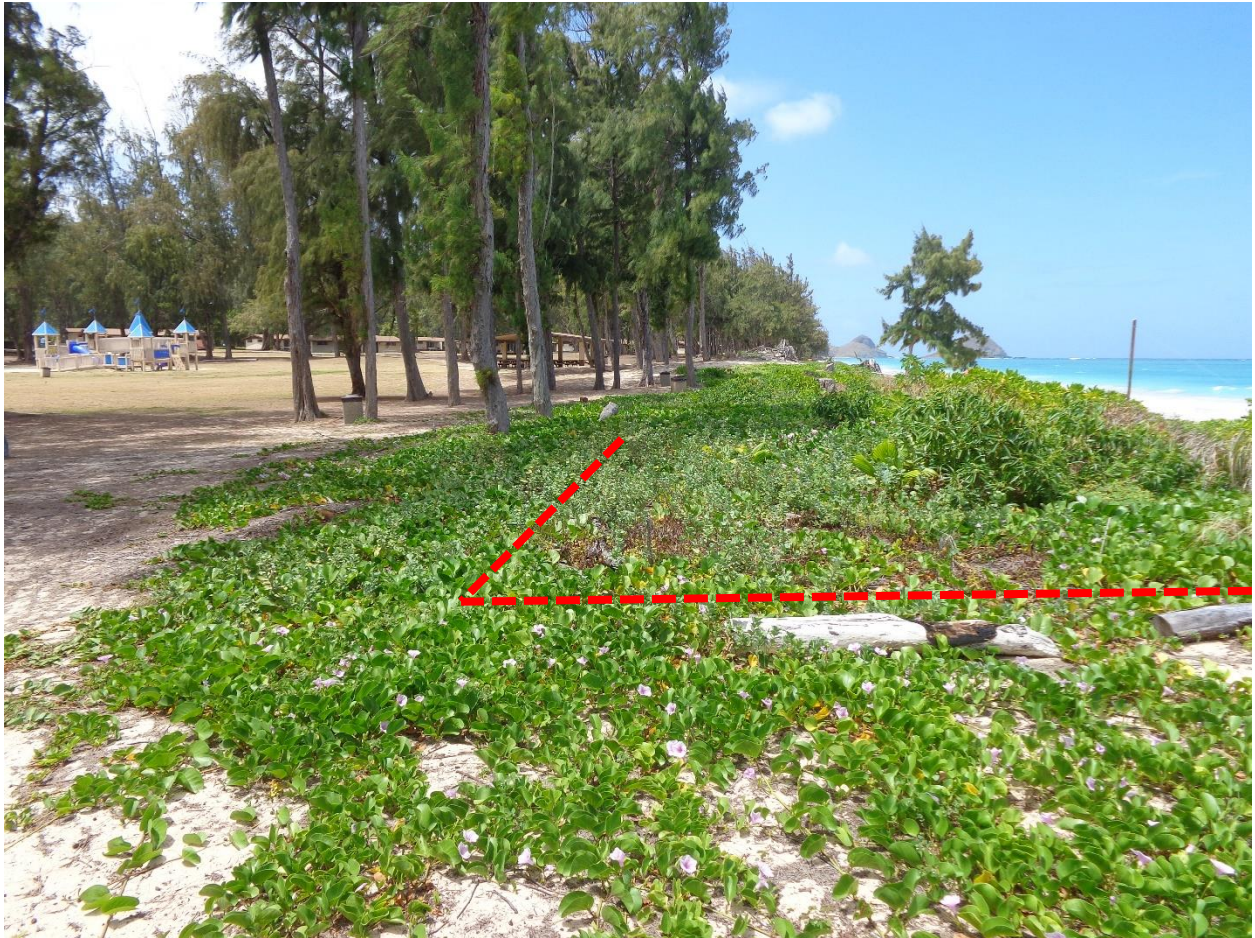
Figure 158. Picture taken 13 months after planting (05/18/2015), showing how the ground cover *Ipomoea pes-caprae* subsp. *brasiliensis* is associated to the trapping of sand, adjacent to a plot planted in November 2014. The dashed line represents a profile of the sand dune level 13 months after planting.

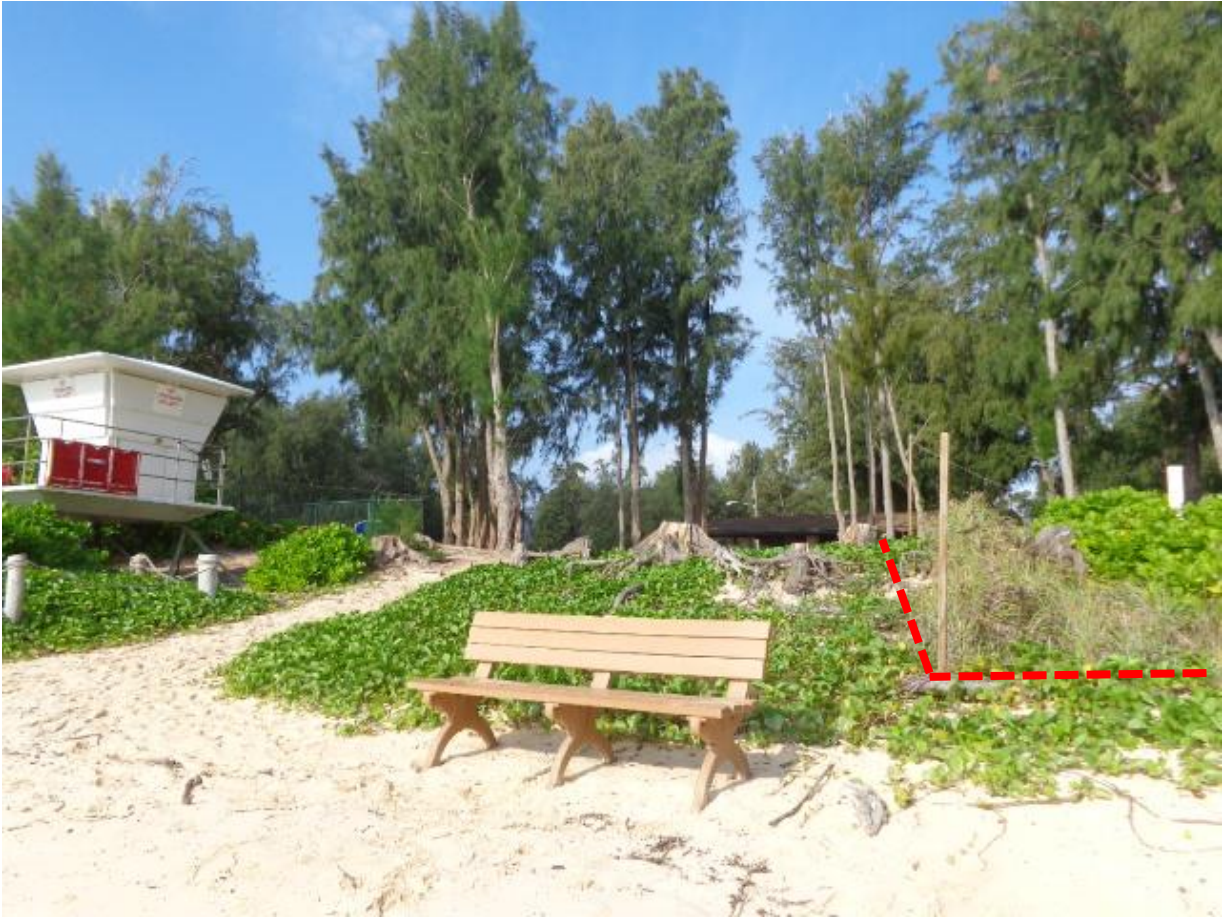
Figure 159. Picture taken Detail 13 months after planting (05/18/2015). Ground cover vines such as *Ipomoea pes-caprae* subsp. *brasiliensis*, *Vitex rotundifolia* and *Jacquemontia sandwicensis* grew beyond the plot planted area, indicated by the dashed lines.

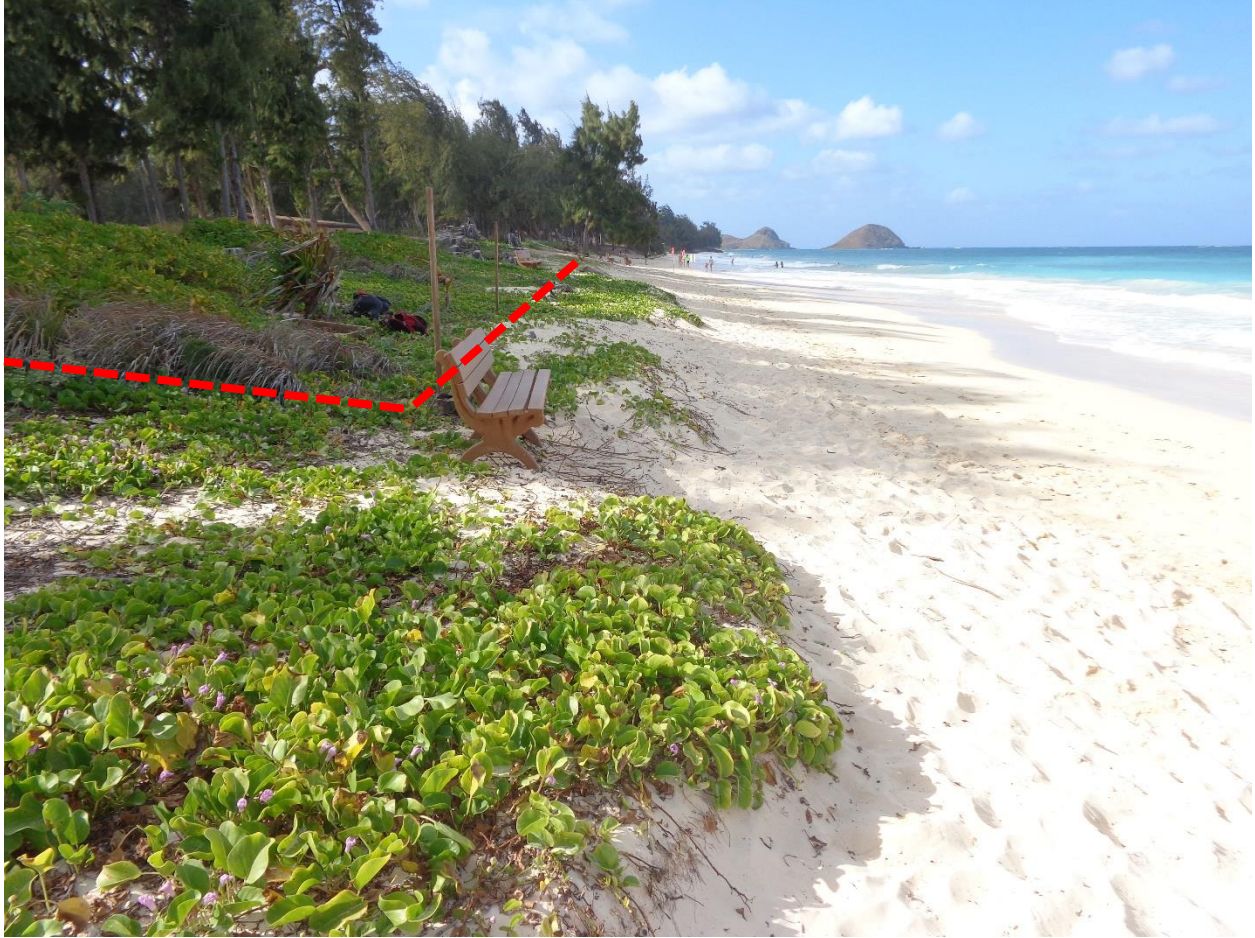
Figure 161. Picture taken 13 months after planting (05/18/2015), showing the advancement of plants on the lateral and beach side of the plot. Ground cover vines such as *Ipomoea pes-caprae* subsp. *brasiliensis*, *Vitex rotundifolia* and *Jacquemontia sandwicensis* grew beyond the plot planted area, indicated by the dashed lines. Note the influence of the vegetation to hold sand.

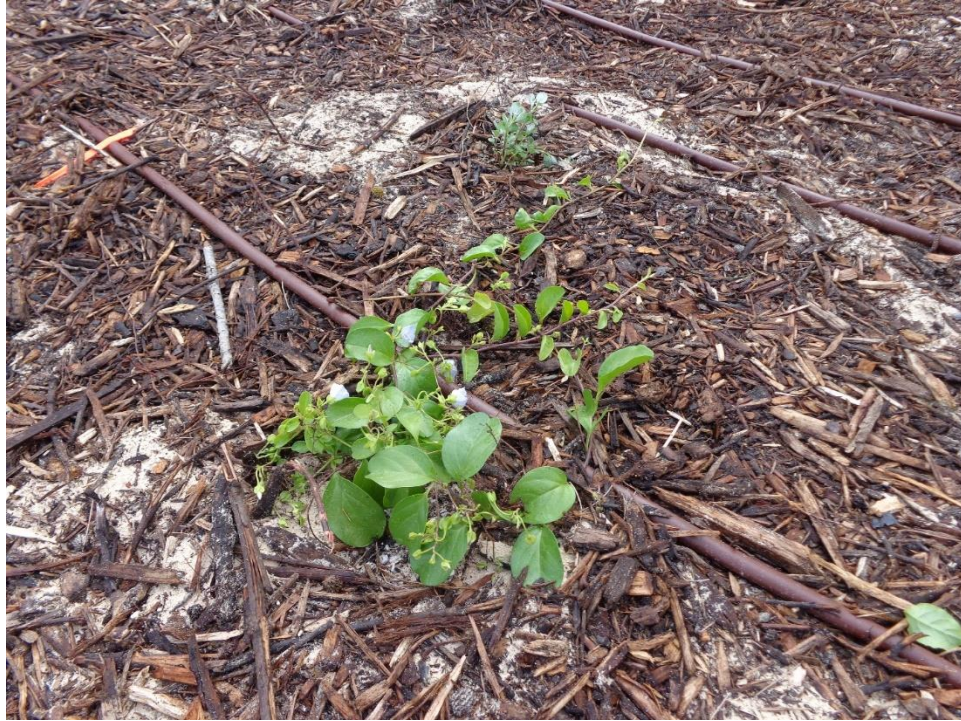
Figure 162. *Jacquemontia sandwicensis* distribution in the dune profile.

Pa'uohi'iaka is another excellent ground cover along with *Ipomoea pes-caprae* subsp. *brasiliensis* for a fast cover of sand dunes, growing throughout the entire dune profile (Table 15 and figures 162 to 166). Pa'uohi'iaka can be seen growing on the edges and empty patches of the plots. However, this attractive ground cover has a short life, and does not grow in competition with other plants such as *Ipomoea pes-caprae* subsp. *brasiliensis*.

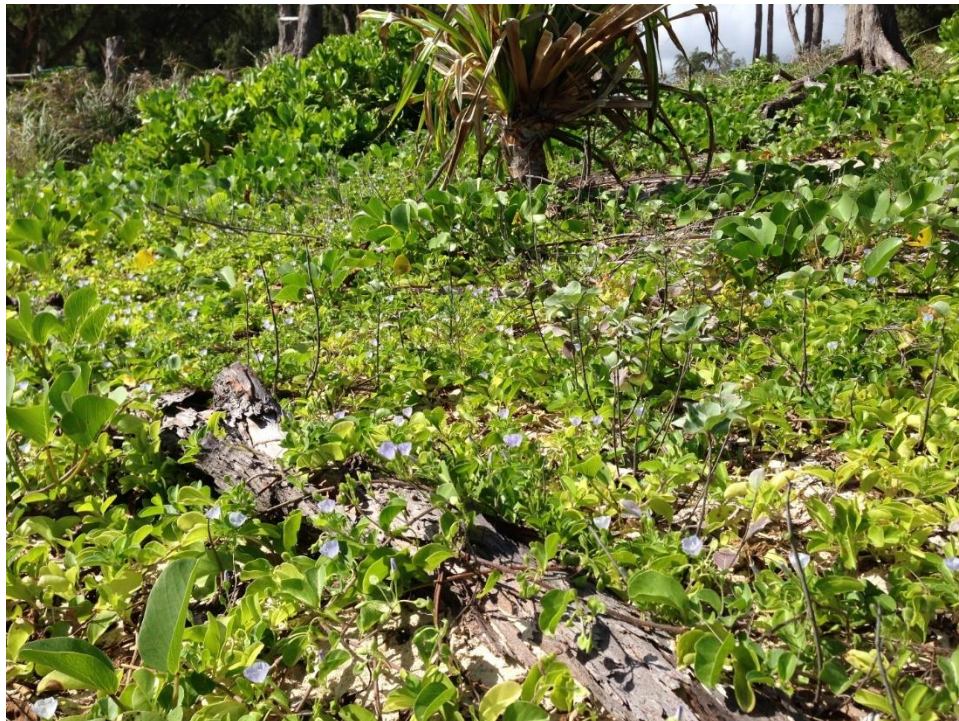
Figure 165. *J. sandwicensis* three months after planting, growing with other groundcovers but not competing with each other.

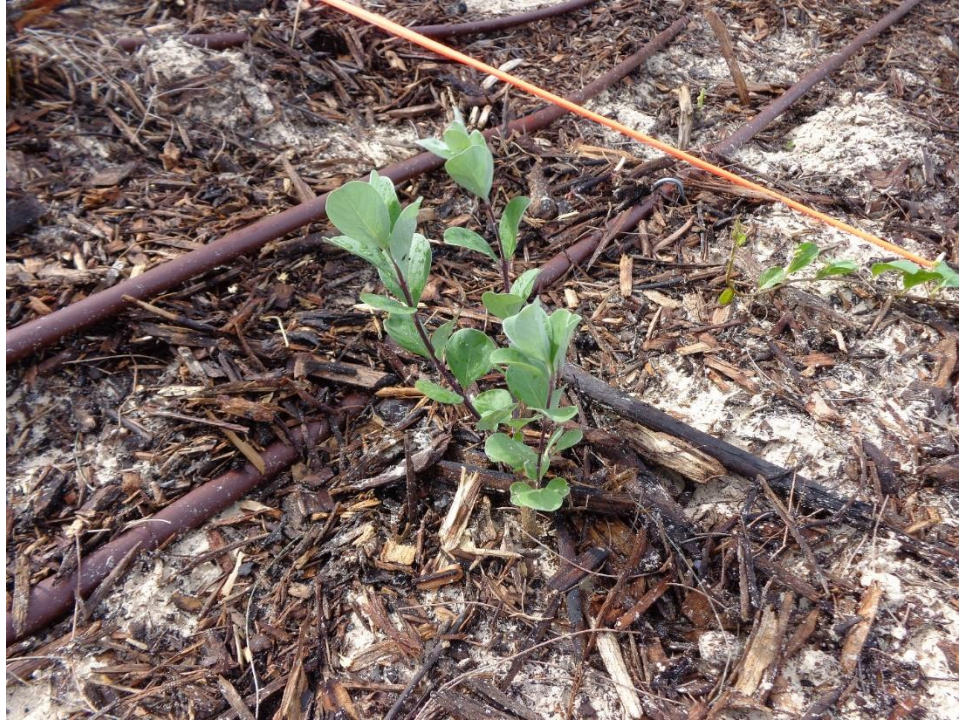
Figure 167. Pohuehue distribution in the dune profile.

*Vitex rotundifolia* is another excellent groundcover along with *Ipomoea pes-caprae*. *Vitex rotundifolia* is very drought and salt tolerant, growing throughout the dune profile and beyond the planted and irrigated areas (Table 18, figures 167 to 171). *V. rotundifolia* grew beyond the planted area towards the mountain, however, it did not grow towards the beach.

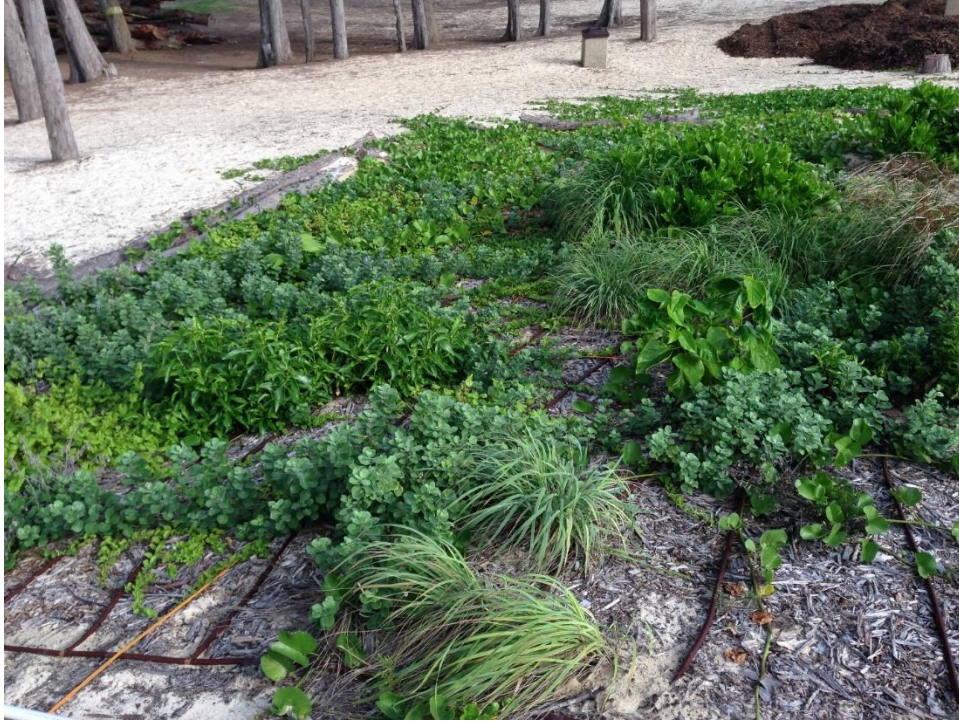
Figure 169. *Vitex rotundifolia* two weeks after planting. Most of the plants lost their leaves and looked like dead, however, they recovered shortly after.

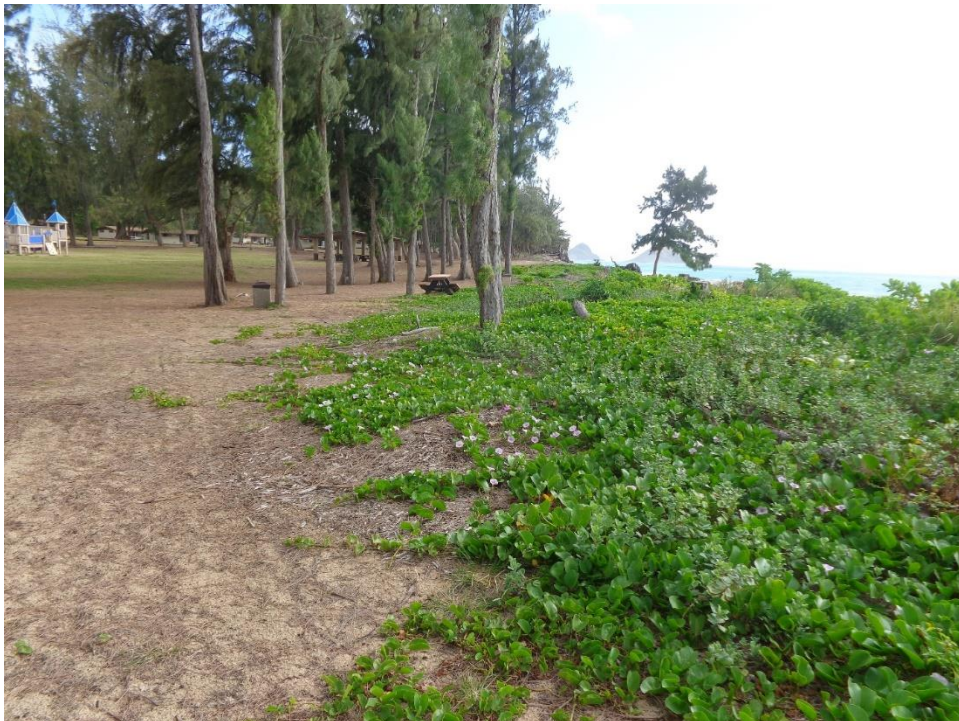
Figure 170. *Vitex rotundifolia* presenting very vigorous growth in the back dune zone, 6 months after planting (10/27/2014).

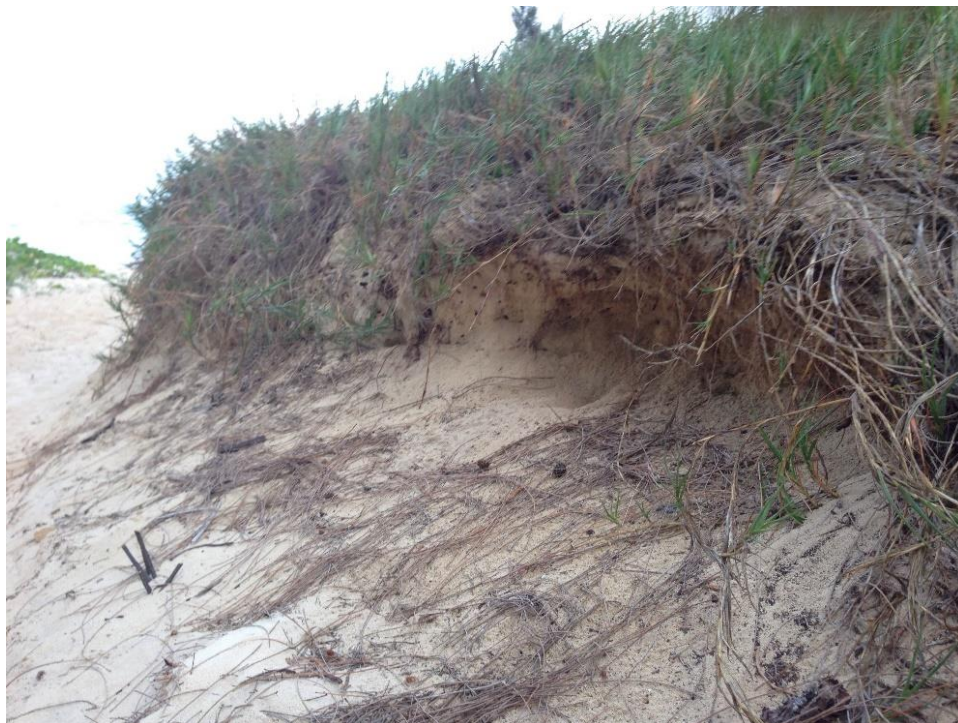
Figure 172. ‘Aki‘aki grass distribution in the dune profile.

‘Aki‘aki grass is a very drought and salt tolerant native grass, growing naturally up to the shoreline in Waimanalo. ‘Aki‘aki grass spreads very easily when irrigated, and can be easily planted with plugs. Existing patches of ‘aki‘aki grass were maintained when existing, and new populations were planted, with a high success. It was notable the capacity to trap sand and to stabilize the sand mounds, growing through the accumulated sand, forming thick carpets that hold the sand in place (Figures 172 to 175).

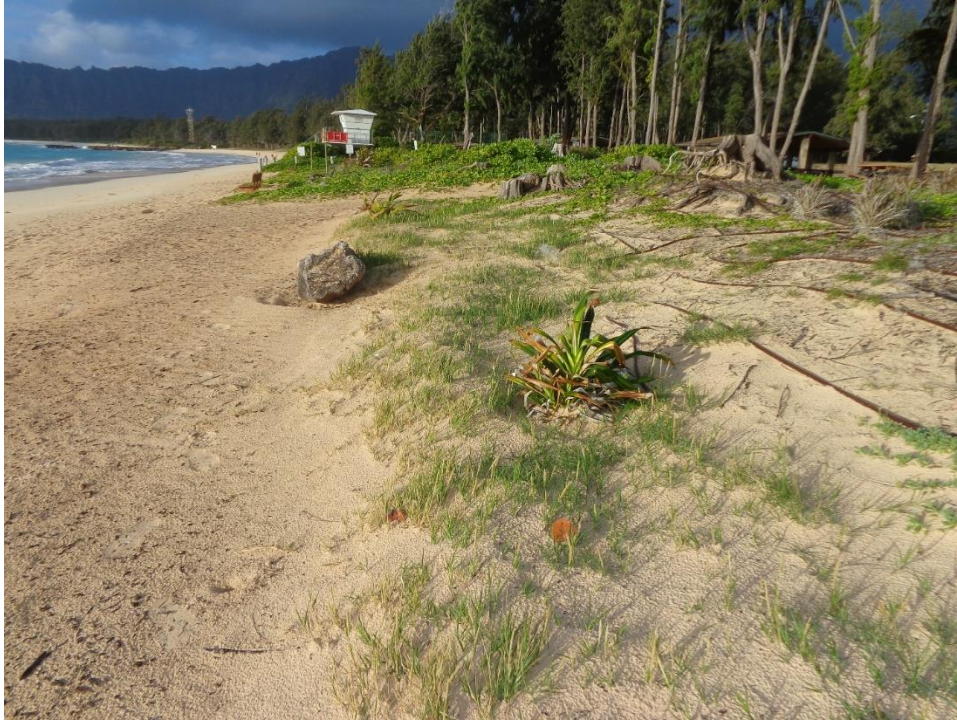
Figure 173. ‘Aki‘aki grass holding the sand dune after storm.

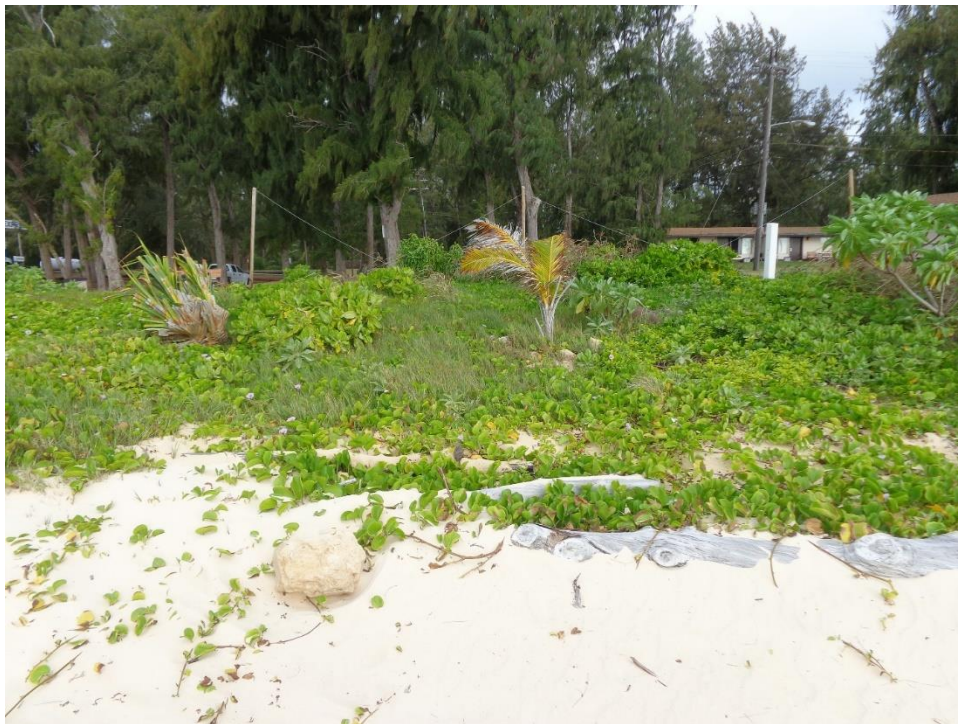
Figure 174. Six months old 'aki'aki grass plantings holding sand dune blown with the tradewinds, grass planted from plugs.

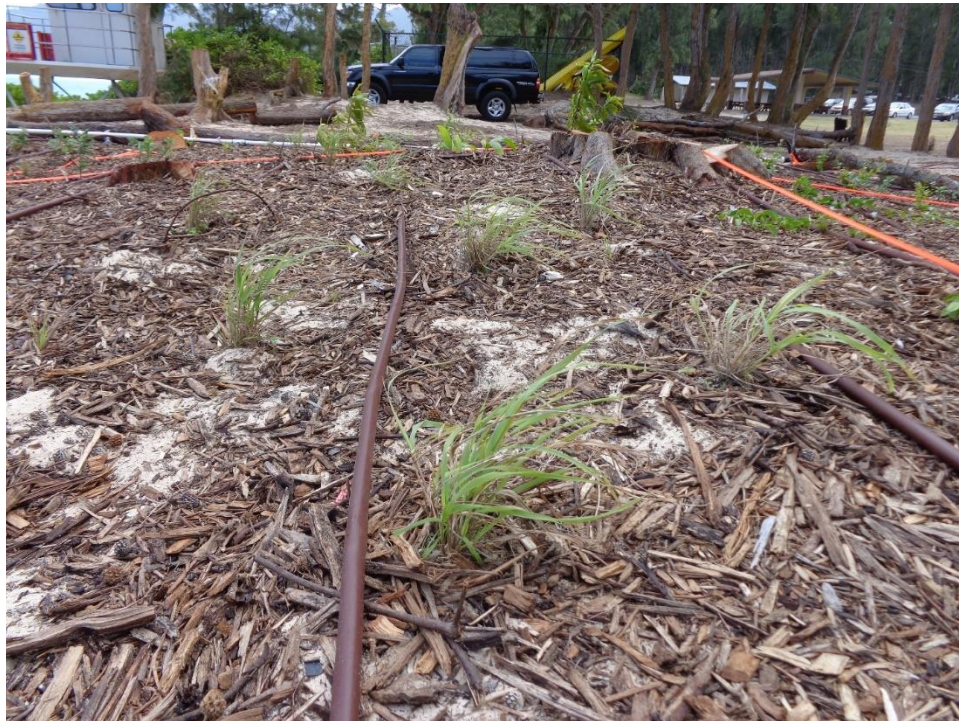
Figure 176. 'Ahu'awa distribution in the dune profile.

‘Ahu‘awa is a native sedge that grows naturally in the wetland along the Waimanalo stream. ‘Ahu‘awa did well in all dune zones (Table 16), with higher heights when protected by the wind. However, plant survival was higher with no windscreen, even though plants were more vigorous when protected from the wind (figures 176 to 183). Plants from the plot with screen seemed to dry faster than those that grew without any protection, probably as a result of stress. Considering that ‘ahu‘awa is a wetland plant, it this difference could be associated to water stress. Plants growing with screens were protected from the wind and the sand was moister than the plot with no screen, which probably resulted in plants with shallower root system compared to the plants growing without screen that had to seek deeper for water. Simultaneously, the plot with no screen experienced more deposit of sand, because the screen did not pose a barrier and the plot with no screen was more exposed to the wind, which comes from the NE direction. Therefore, sand accumulated more in the plot with no screen, which covered the irrigation system, making it deeper, resulting in less loss of water through evaporation. Therefore, when the screen was removed, the plants from the plot with no screen were adapted to the wind and salt spray, and with deeper root system and deeper irrigation dripline, and more able to overcome stresses from the elements. This conditions apply to many other plants.

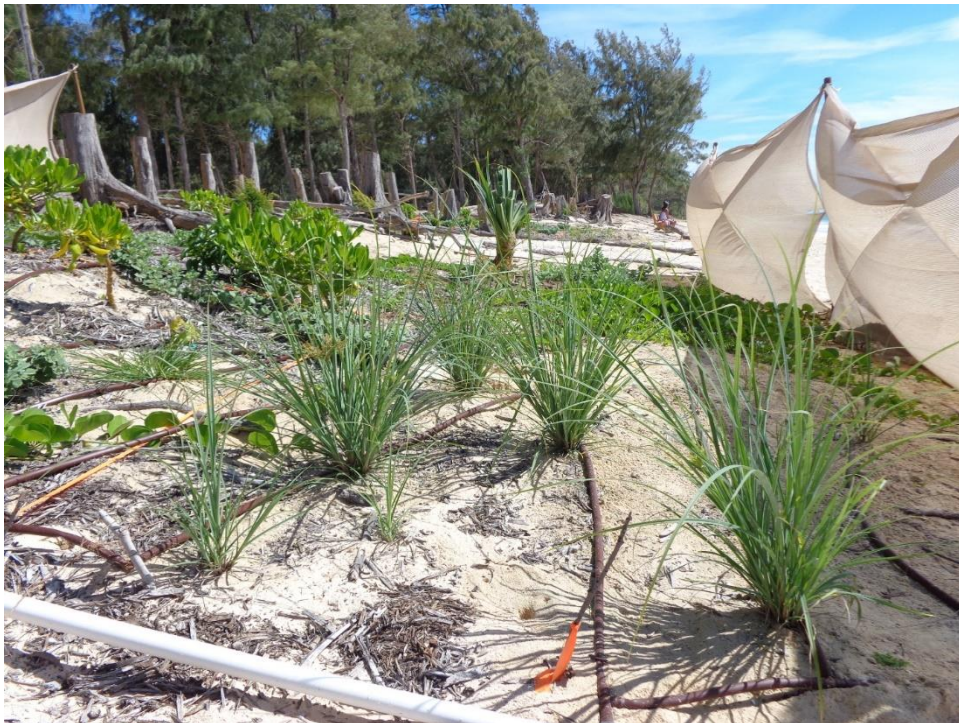
Figure 178. 'Ahu'awa growing in plot without windscreen, 3 months after planting (07/11/2014)

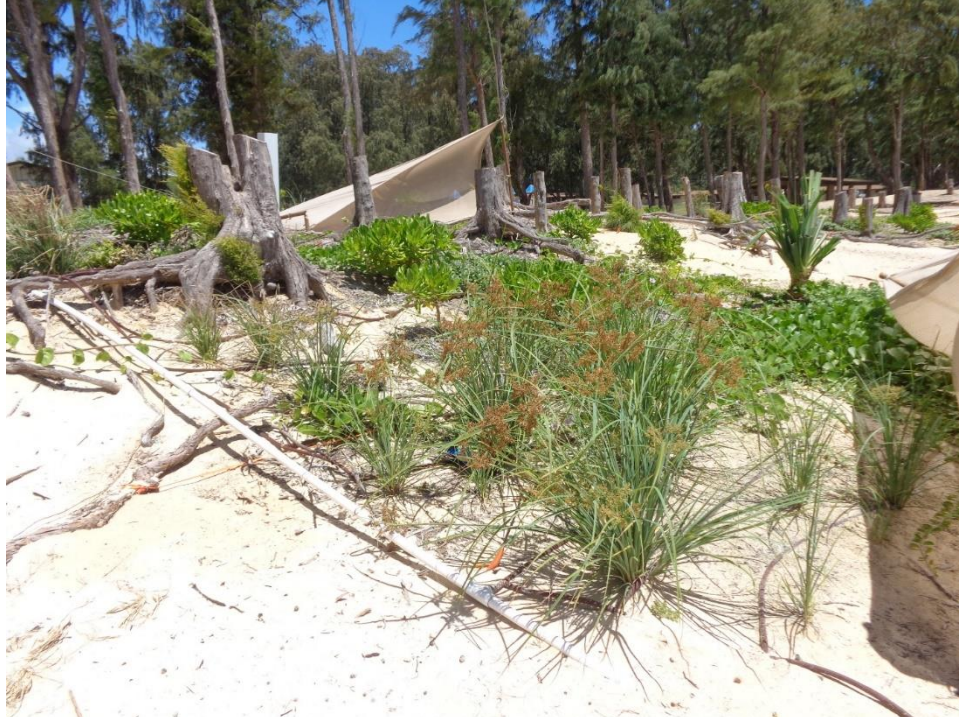
Figure 179. 'Ahu'awa sheltered by windscreen, 3 months after planting (07/11/2014).

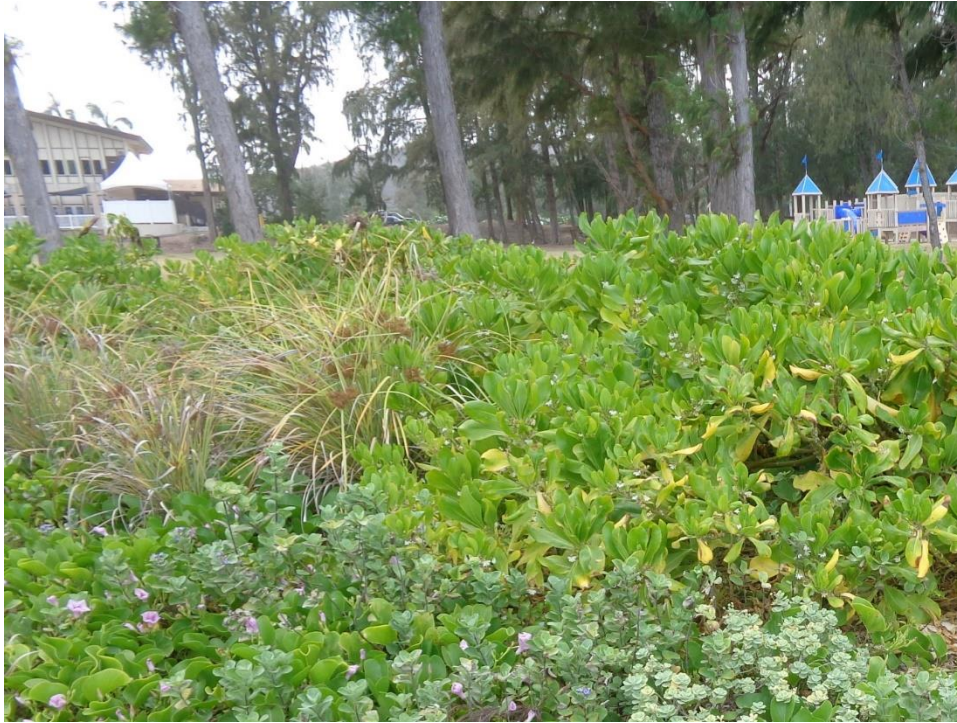
Figure 181. Nine months after planting (01/27/2015), 'Ahu'awa was still thriving. Plants from the plot that had windscreen for two months were clearly larger than those plants that did not have any protection.

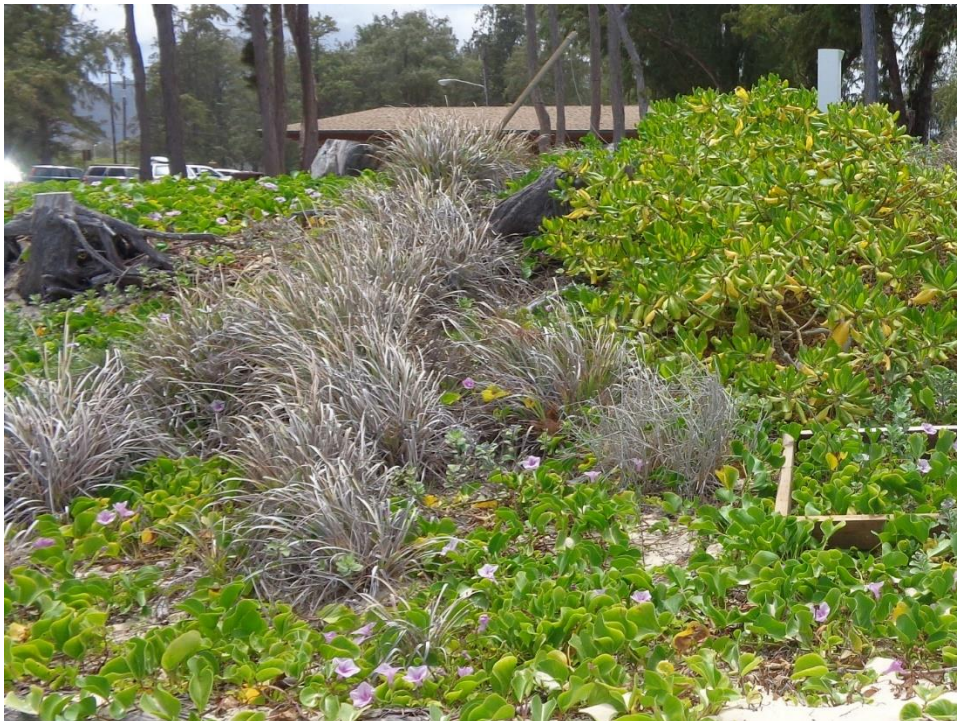
Figure 182. 'Ahu'awa growing in the plot without windscreen (picture taken on 05/18/2015, 13 months after planted).

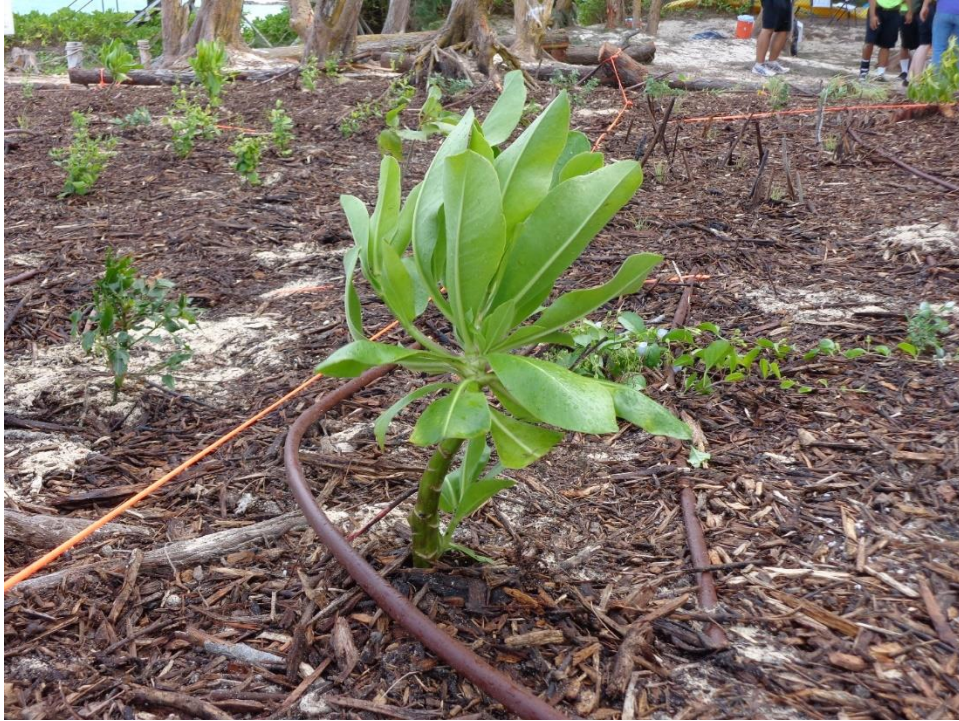
Figure 184. *Scaevola taccata* distribution in the dune profile.

Naupaka is a popular shrub in the landscape industry and is easily found growing all around the coast of the Hawaiian Islands. It is very common in Waimanalo and provides wind and salt protections for other native plants such as *Sida fallax*, *I. pes-caprae* and *J. sandwicensis*. The plants in this trial did very well (Table 17) and, as in the natural environment, provided protections to other plants that grew behind them, following their growth rate, such as *Cordia subcordata* (184 to 190). This phenomenon was previously described in the work of Thaman et al. (1995) in Tonga. Naupaka can grow in all dune zones, however, it is more appropriate to the dune crest and back dune, since it tends to spread and form large volumes.

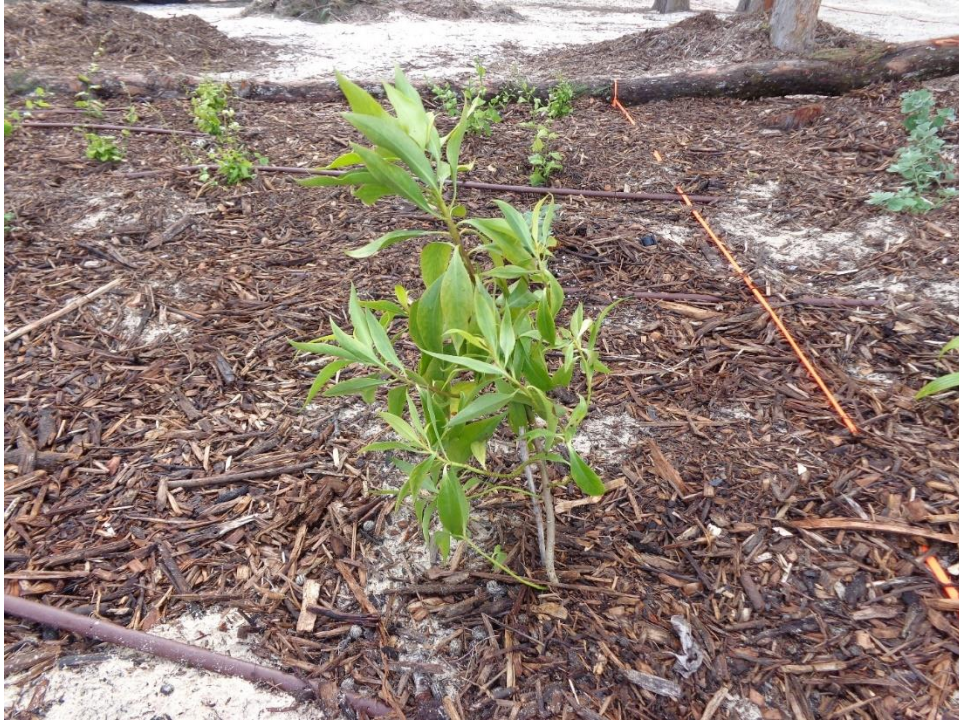
Figure 191. Naio distribution in the dune profile.

Naio (*Myoporum sandwicense*) is a native plant cultivated in two forms: shrub and prostrate. Both forms did very well in these trials (Table 18). The shrub form suffered from mealy bug attack, which was controlled with organic insecticide (191 to 195). Naio has a dense canopy, which provides protection to young and less salt-tolerant plants, similar to naupaka.

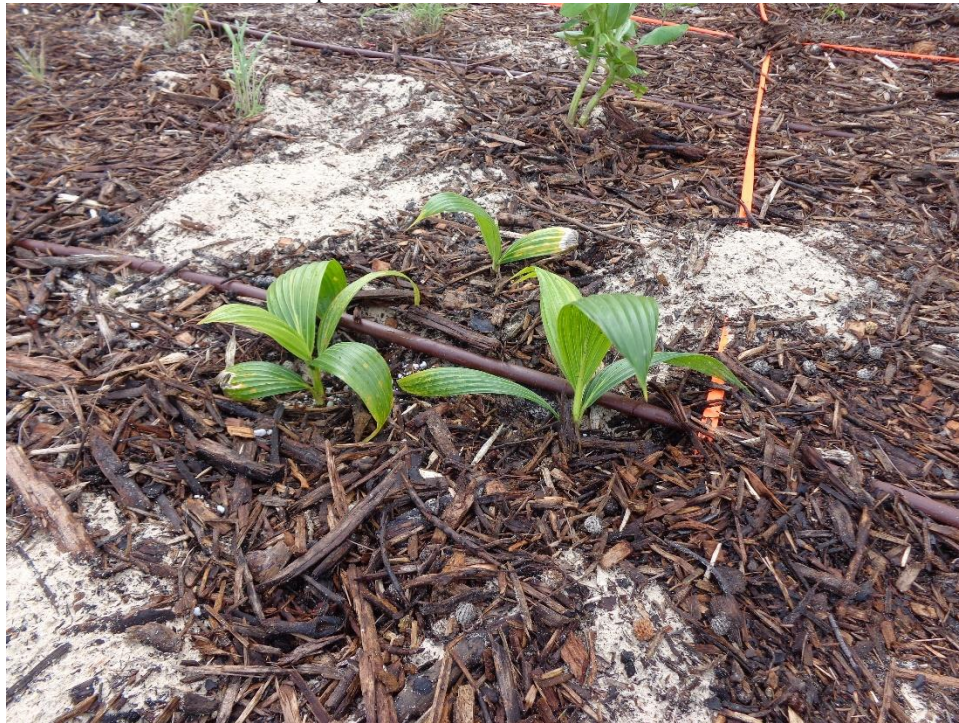
Figure 196. Loulu distribution in the dune profile.

Loulu did well in both plots, with or without screen. It was planted in the backdune of the plots (figures 196 to 199). Because of its slow growth rate, there not much to say about it in one year, besides the fact that it is a promising palm for dune restoration.
